# **Lateral Plungers** • with thread, without seal, with female thread

22150,1331

### **Product Description**

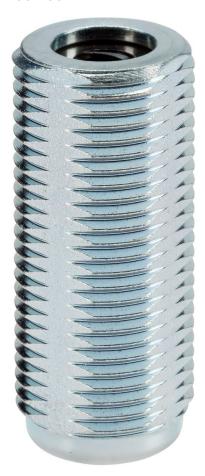
To be used for positioning and applying pressure, e.g. during painting and sandblasting.

Lateral plungers are installed by screwing in by means of a mounting tool.
